Manhole Inspection Summary

Manhole # S19I__046MH

Insp Date: **3/4/08 11:45 AM**

Location Address: **32 boyd st**

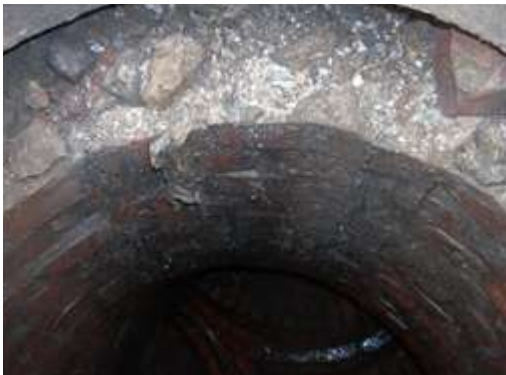
Defect 3

Infiltration: ☐ None ☒ **Joint** ☐ Cracks ☐ Mortar ☐ Roots ☐ Wall

infiltration evidence at the joint

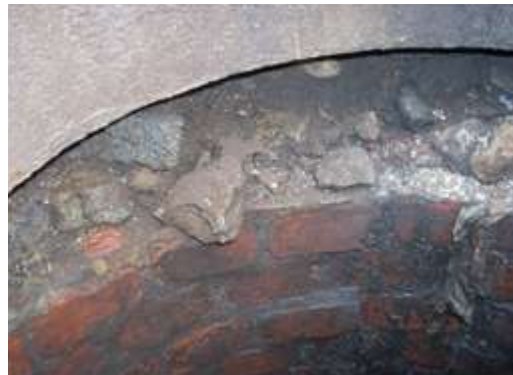
Defect 2

Condition: ☐ Sound ☐ Cracked ☐ Root Intrusion ☐ Loose Brick ☒ **Deteriorated**

deteriorated corbel

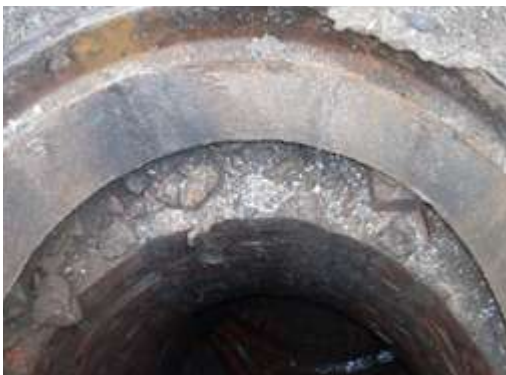
Defect 1

Frame Offset: **4** (in.) Condition: ☒ Sound ☐ Cracked ☐ Leaks

frame offset

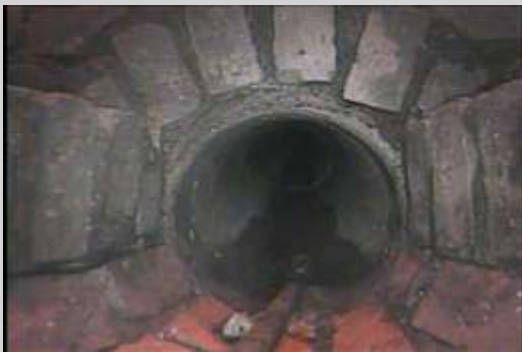
12 O'Clock Outflow

8 in. Circular Gravity Sewer
Pipe Out @ 12 O'Clock

Pipe Height: **8.4** (in.) Rod and Bar (Angled)
Pipe Material: **Clay** ☐ Pipe Lined
Invert Depth: **8.56** (ft.) Flow Characteristics: **Slow**
Deposits: ☐ None ☐ Mud ☐ Sludge ☒ **Debris** ☐ Grease
Silt Depth: **1** (in.) Deposits Extent: **Light**
Infiltration: **None** Pipe Seal Cond: **Sound**

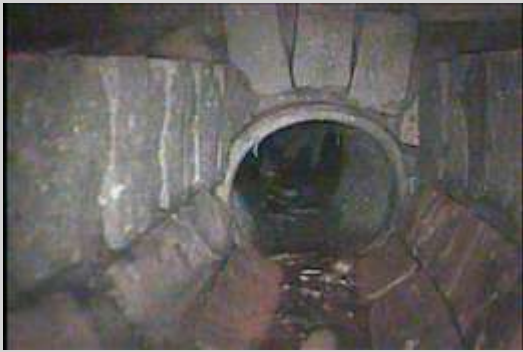
5 O'Clock Inflow

6 in. Circular Gravity Sewer
Pipe In @ 5 O'Clock

Pipe Height: **6** (in.) Rod and Bar (Angled)
Pipe Material: **Clay** ☐ Pipe Lined
Invert Depth: **8.30** (ft.) Flow Characteristics: **Slow**
Deposits: ☐ None ☐ Mud ☐ Sludge ☒ **Debris** ☐ Grease
Silt Depth: **1** (in.) Deposits Extent: **Light**
Infiltration: **None** Pipe Seal Cond: **Sound**
